**Report of Dr. Brenton Cox
Regarding the May 31, 2017
Explosion at Didion Milling in
Cambria, Wisconsin**

March 31, 2023

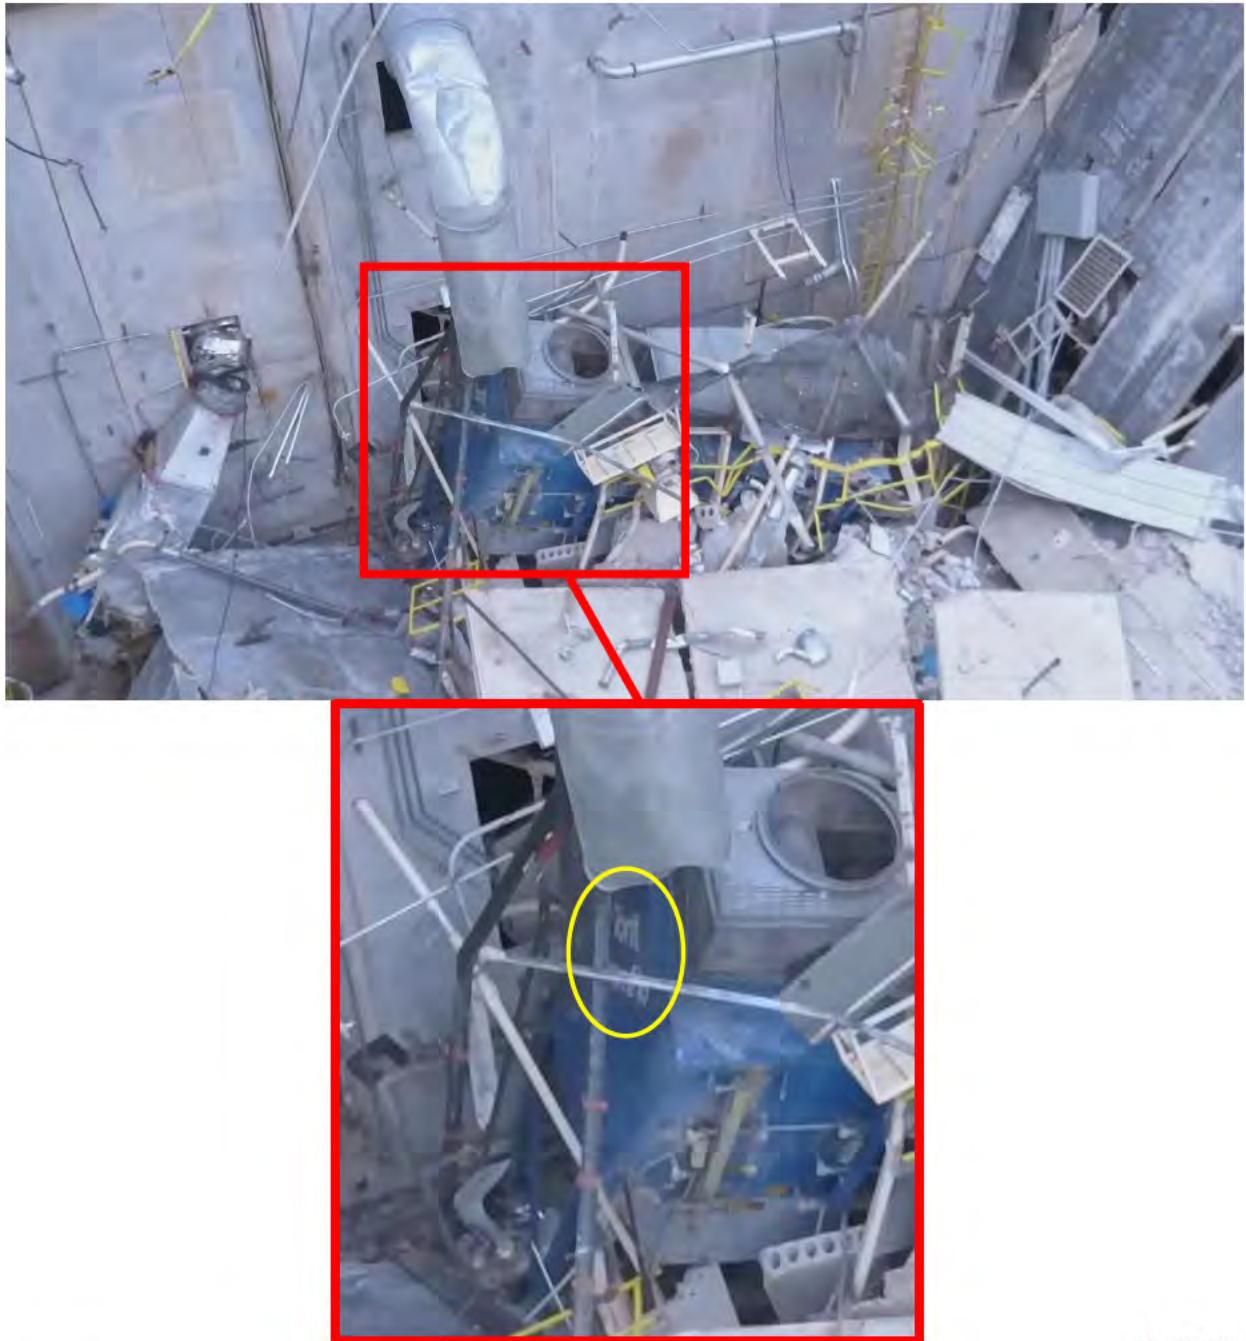
DJI_0005 MOV

Figure 47. Post-incident aerial view of Torit Filter.¹⁹⁰

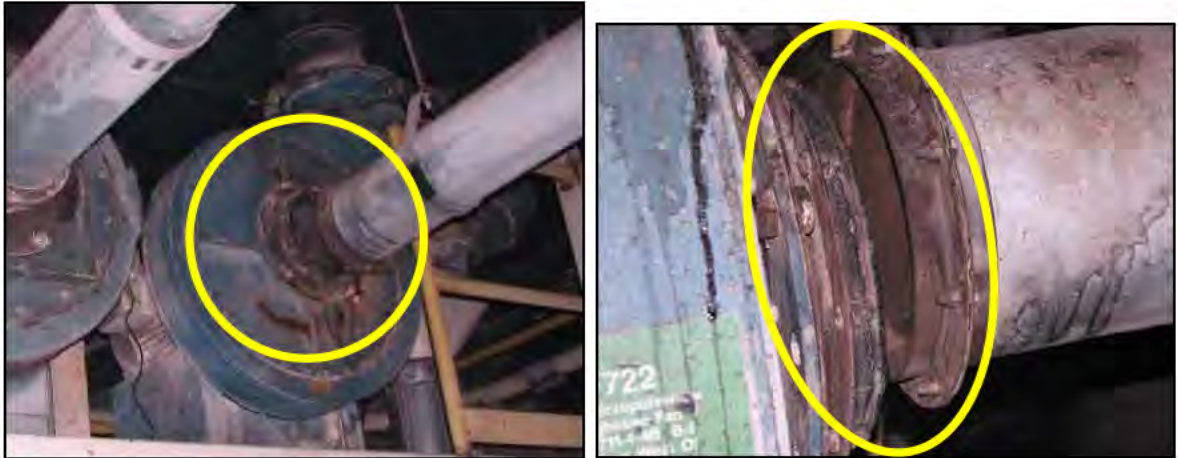
D16680 – 0296 (left); D16682 – 0049 (right)

Figure 50. Post-incident view of SBM Fan on Mezzanine in B1 with zoomed in photo showing separated duct and clear soot deposition.

Incontrovertible evidence of flame propagation through the SBM Fan is shown in Figure 50. The flexible connection between the SBM Fan and its inlet duct was destroyed during the event, and signs of internal heat and flame can be seen inside and out. As discussed in Opinion 2, the flame propagated through the SBM fan into the Torit system, which is evident by section 3.2.

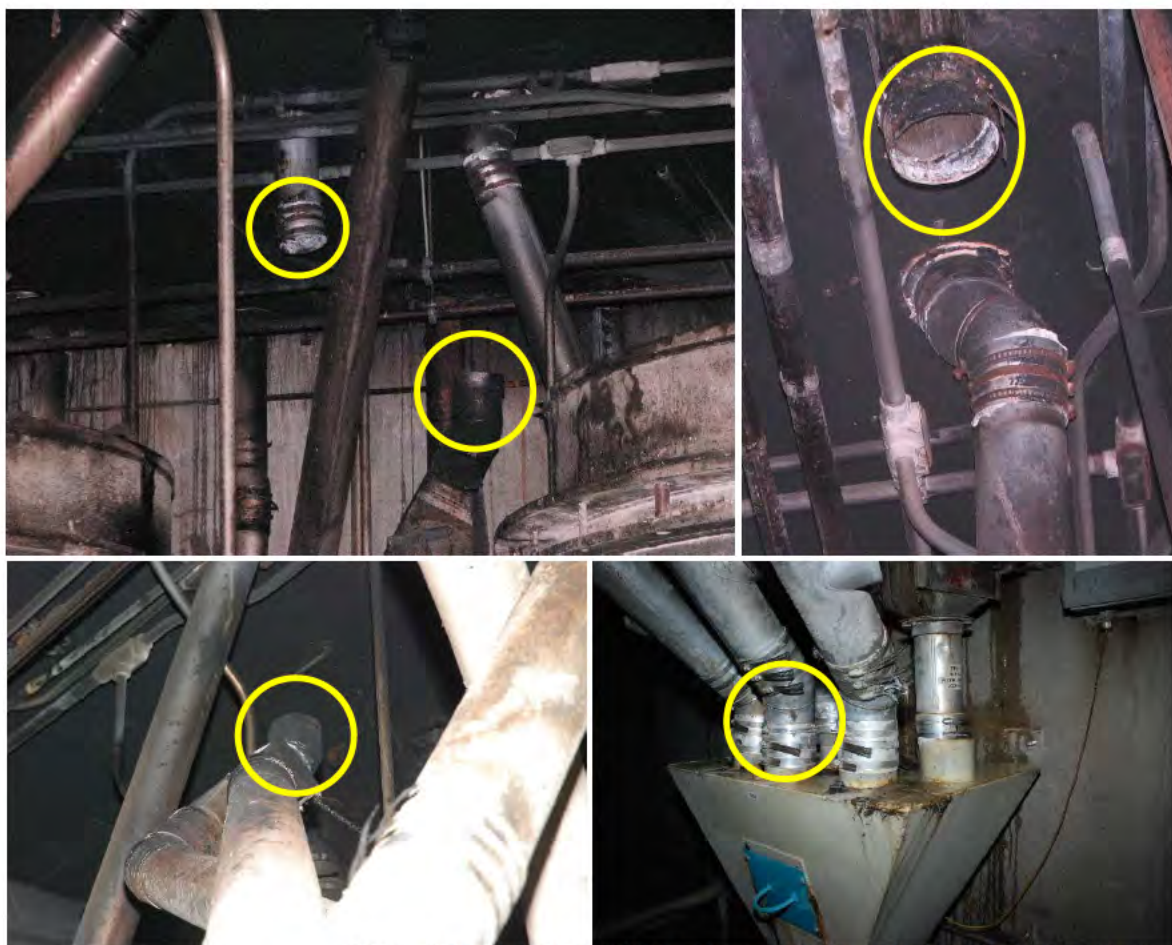
D16682 – 0131 (top, left), D16682 – 0156 (top, right; cropped) D16677 – 0323 (bottom, left), D16677 – 0324 (bottom, right)

Additional separated ducting is shown below in Figure 52. The separated spouts were connected to an inlet line to the Feed airlock. Additional splatter from projected fuel (mill product) onto the wall of B1 can be observed in Figure 53 from the Pregel Hammermill/Bauermeister intake line.

Figure 52. Post-incident view of separated spout associated with an inlet to the Feed airlock, both located behind the SBM and NBM (seen in the foreground).

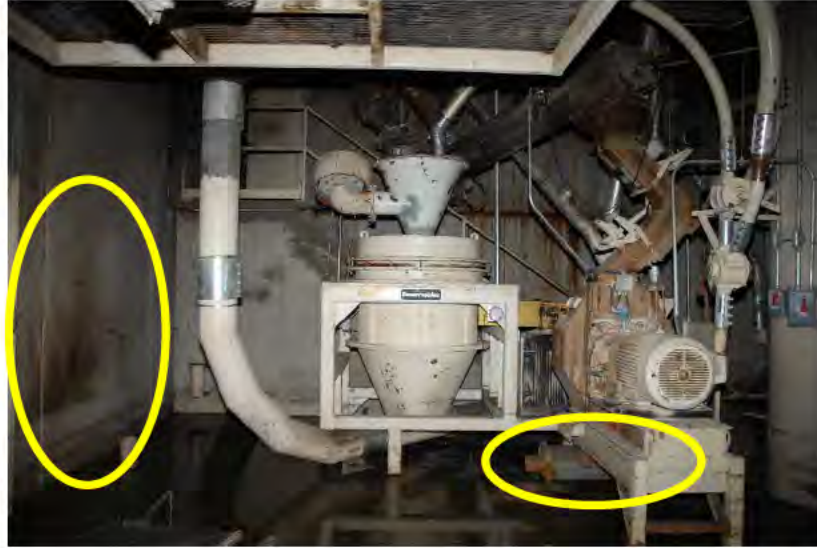
D16677 - 0106

Figure 53. Post-incident view of splatter on the wall (left) and the Pregel Hammermill/Bauermeister intake line (right).

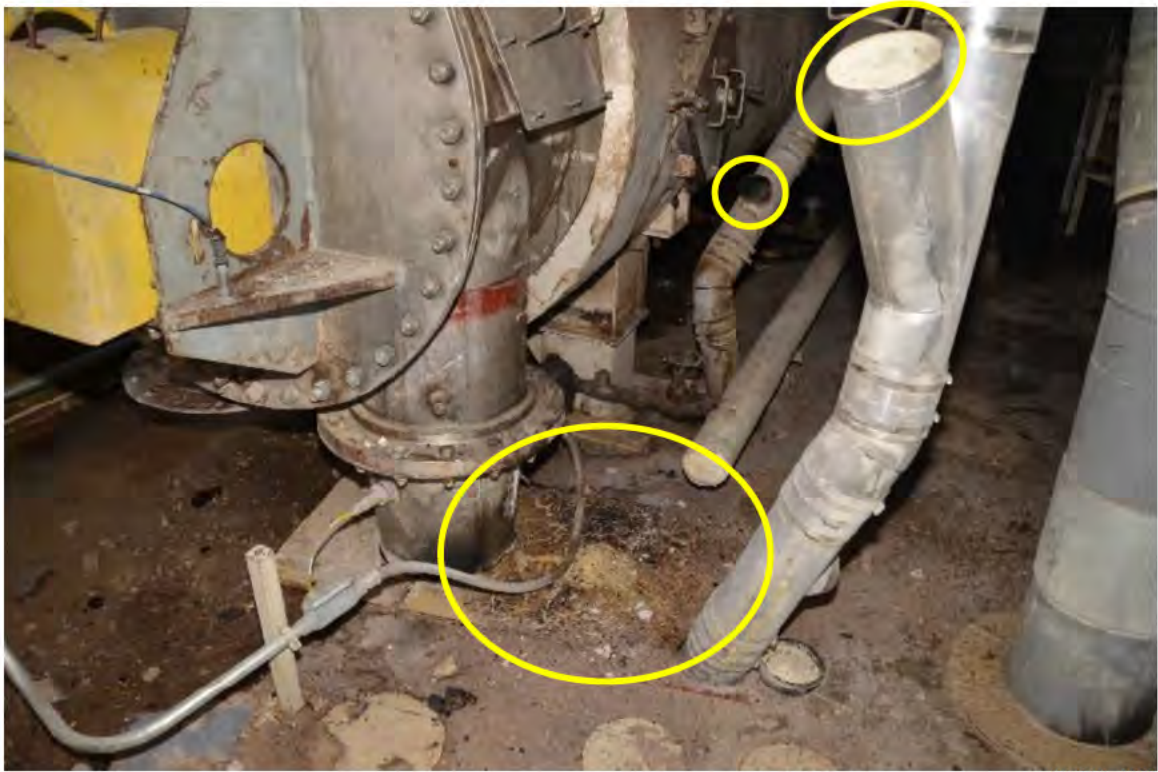
D16680 - 0683

As described in Section 3.2, the explosion propagated internally through the ducting and equipment across the mill. Additional open pipes with evidence of burned material as a result of product ejected from internal ducts is shown below in Figure 54. Figure 55 depicts the separated duct between Expander 1 and the Expander 1 Solidaire. Deposits of burned material ejected from the separated duct can be seen on adjacent piping.

Figure 54. Post-incident view of burned material released from separated and/or blown-open pipes on 2nd floor of B-Mill.

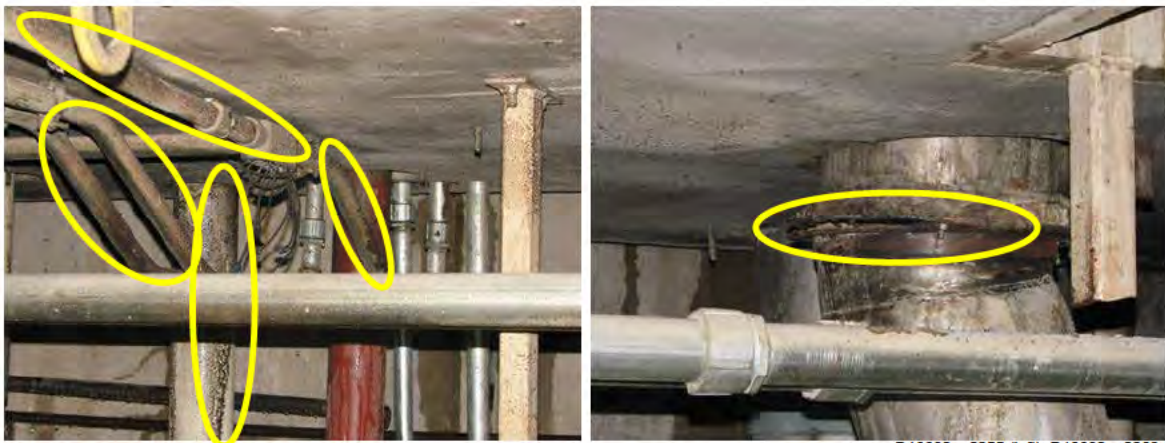
D16682 - 0255 (left), D16682 - 0263 (right)

Figure 55. Post-incident view of separated duct between Expander 1 and the Expander 1 Solidaire near the ceiling of 2nd floor of B-Mill (right) ejected burned product horizontally (left).

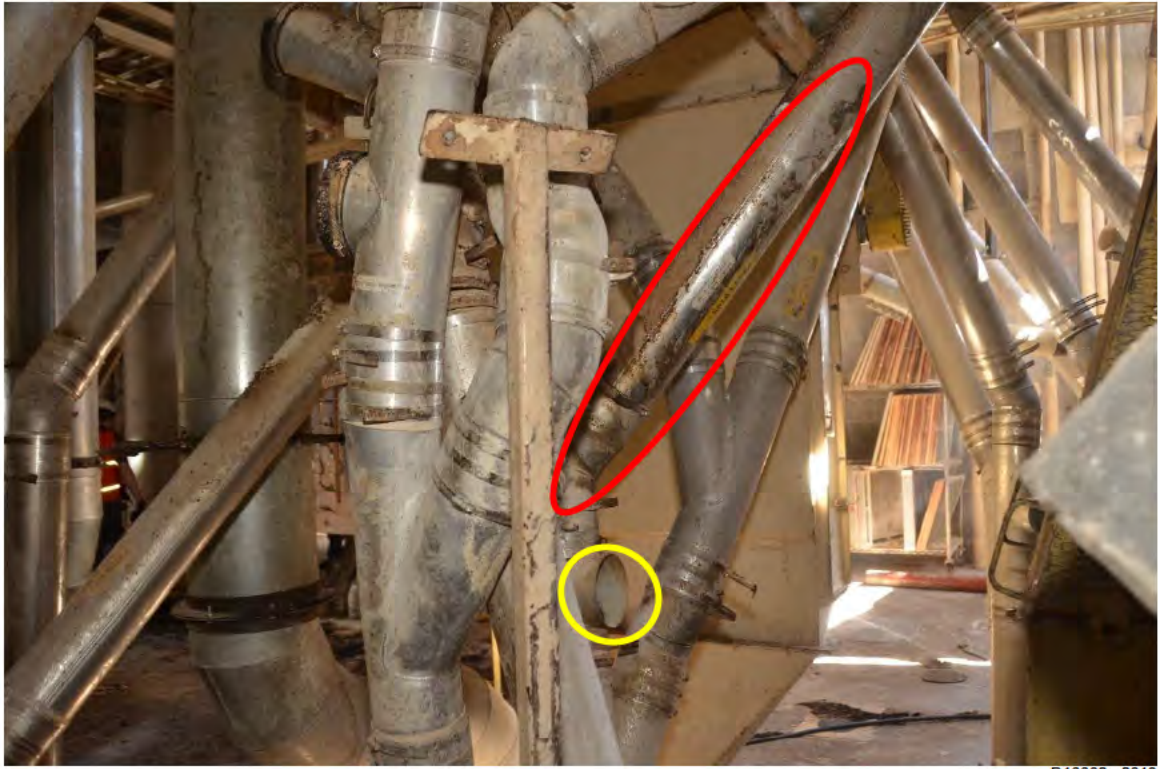
D16680 - 0813

Figure 61. Post-incident view of additional ducting on the 3rd floor of the B-Mill exhibiting burn patterns from ejected product splatter.

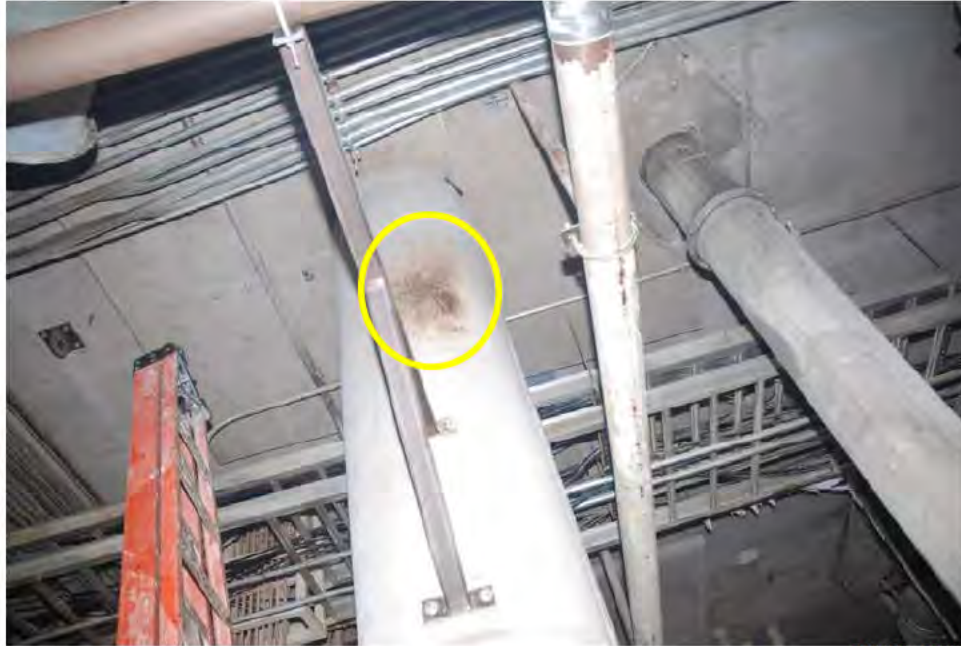
D16686 - 00972

Additional soot deposition from burned product projected from an open duct on the 3rd floor of the B-Mill can be observed in Figure 64.

Figure 64. Post-incident view of soot deposition from burned product projected from an opened duct on the 3rd floor of B-Mill.

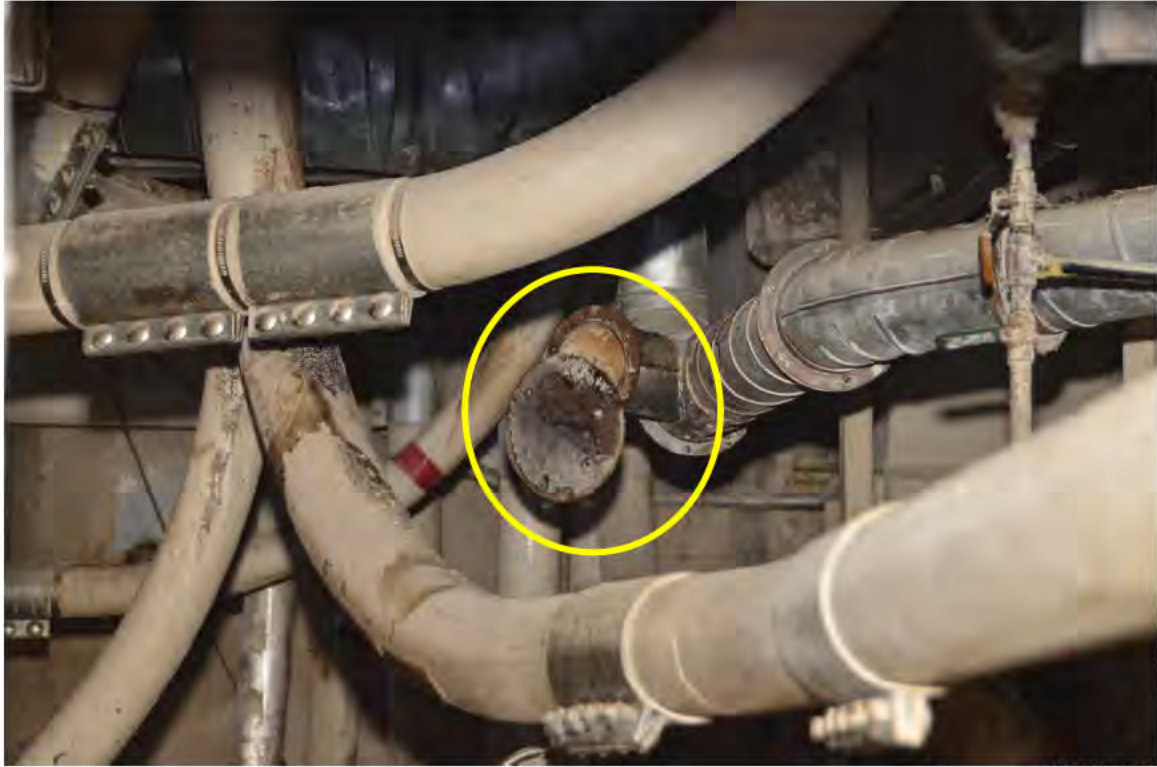
D16681 - 0044

The A-Mill also shows evidence of blind ducts that experienced an internal overpressure event and of soot deposition from burned, ejected material, as shown in Figure 66.

Figure 66. Post-incident view of a separated flange in A1.

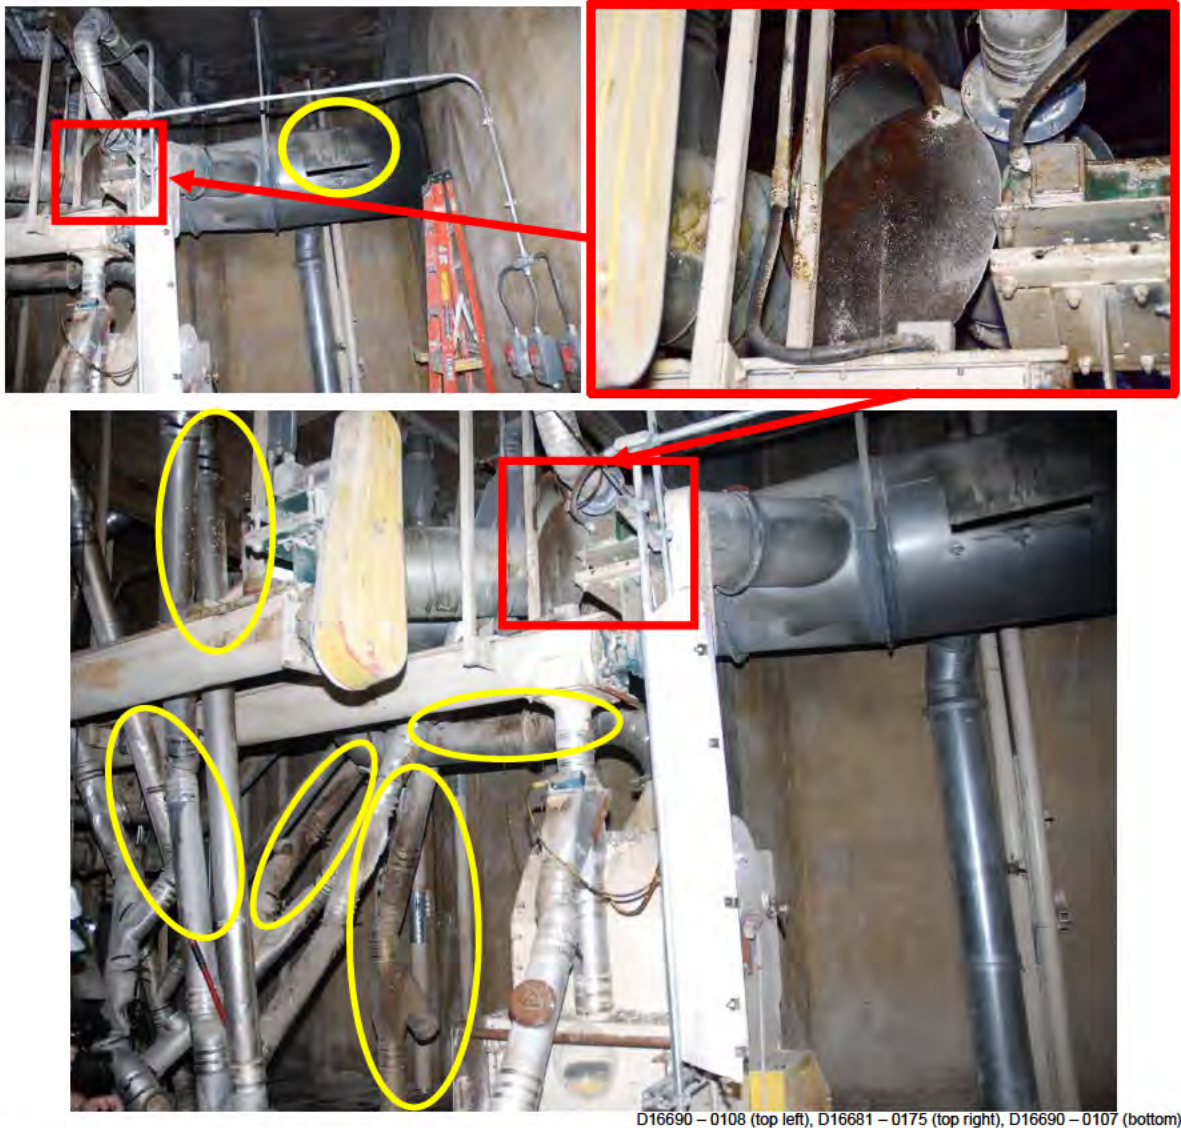
D16690 – 0108 (top left), D16681 – 0175 (top right), D16690 – 0107 (bottom)

Figure 69. Post-incident view of Torit Filter Header entering the 2nd floor of the A-Mill (top left) with the access door and blind blown off due to internal overpressure in Torit Filter Header (top right) resulting in burn splatter on surrounding piping in A-Mill (bottom).

As observed in Figure 69, a clear overpressure occurred on the 2nd floor of the A-Mill where the Torit Filter Header entered the building. In the top left photo, the access door on the 36" Torit Filter Header is shown to have popped open due to internal overpressure. As seen in the top

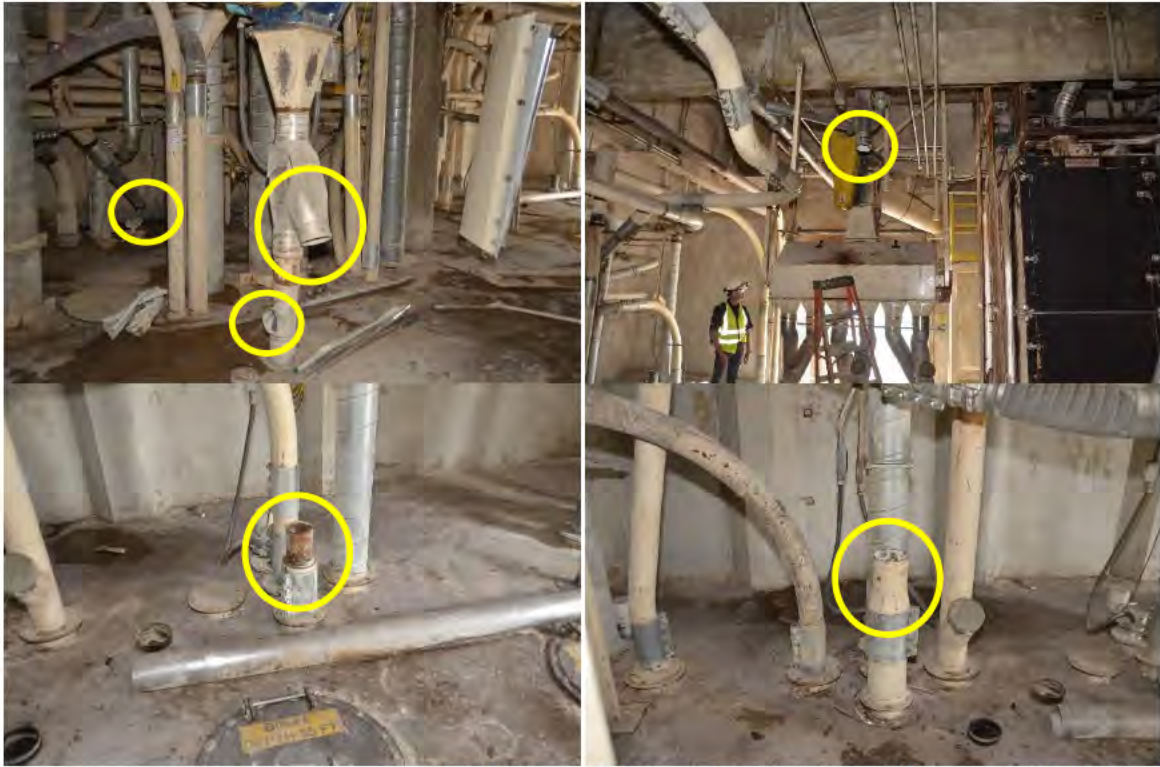
D16681 - 0425 (top left), D16681 - 0452 (top right), D16681 - 0458 (bottom left), D16681 - 0460 (bottom right)

Figure 73. Post-incident view of process lines that have been separated or had their flanges or caps blown off by the event in the A-Mill (5th floor).

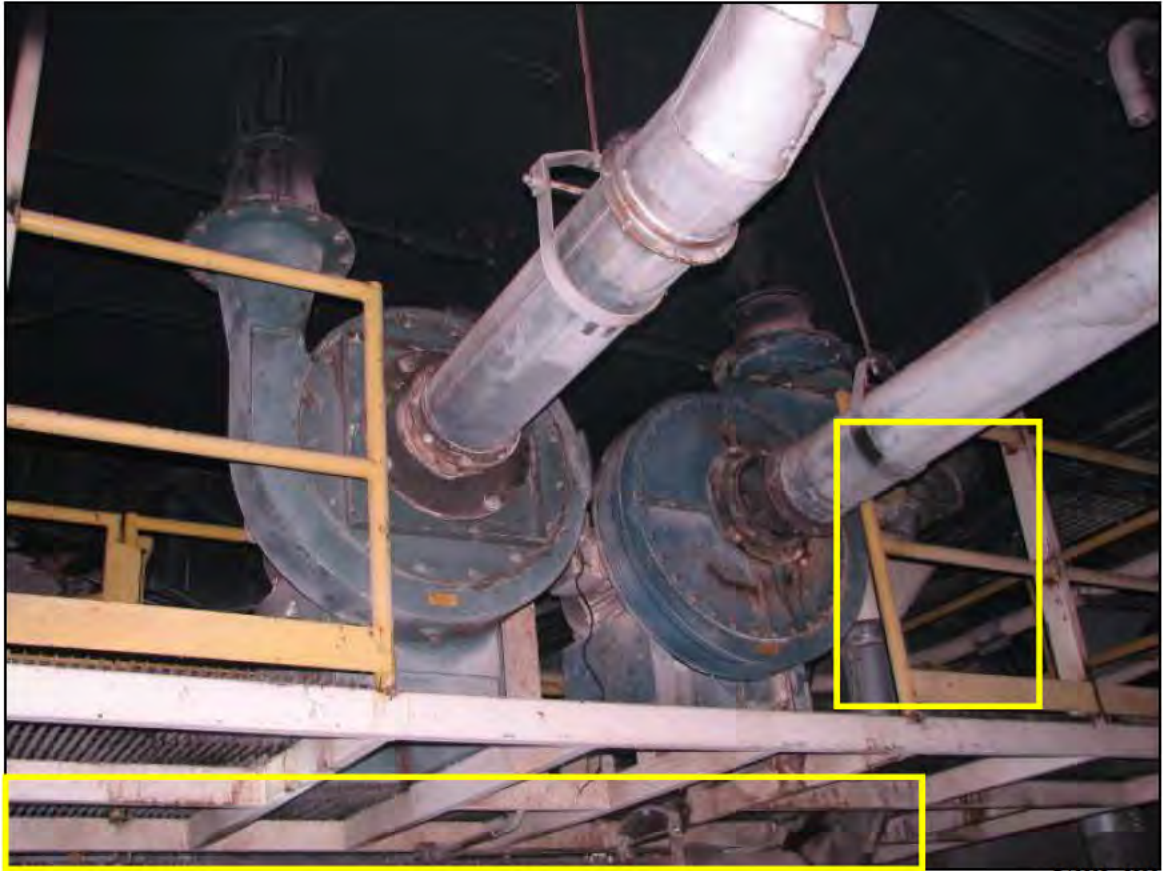
Figure 75. Post-incident view of the Government lift gate shown below the NBM and SBM Fans in B1. The air intake can be seen on the right, behind the SBM Fan.

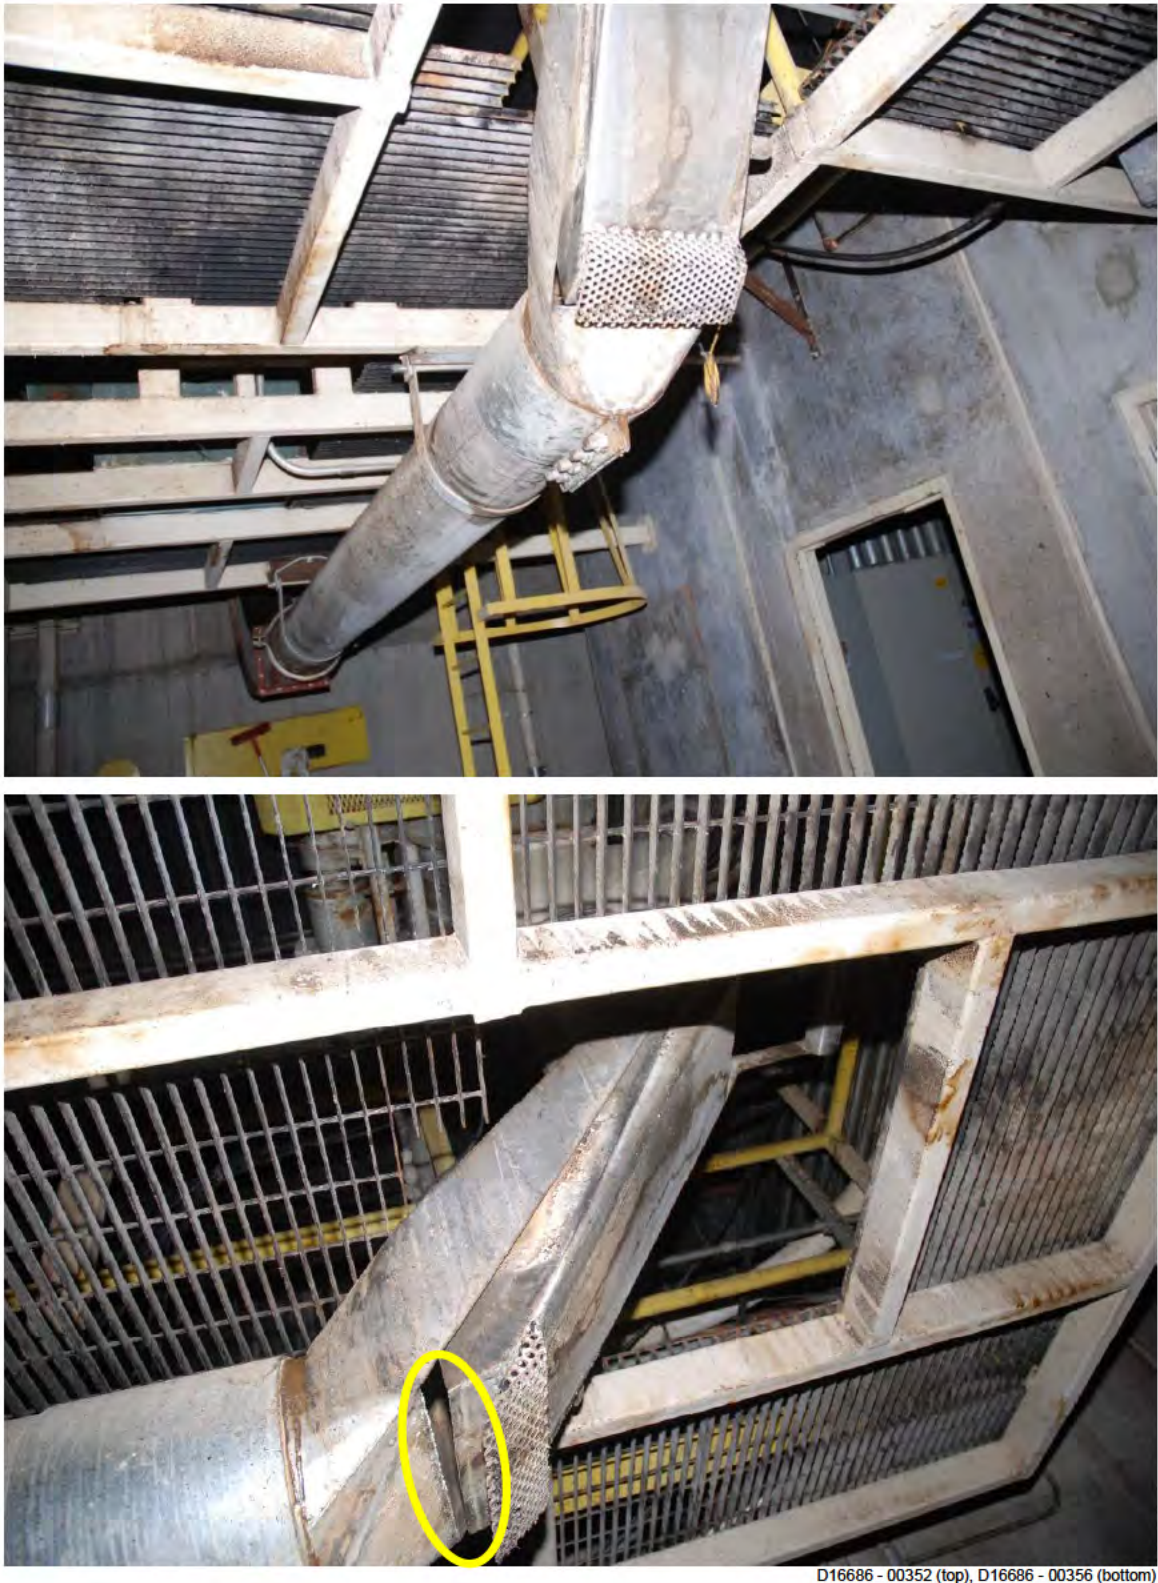
D16686 - 00352 (top), D16686 - 00356 (bottom)

Figure 76. Post-incident view of Government Line lift gate (top) with zoomed in photo of the lift gate slightly open (bottom) on B1.

The Government Line lift gate is a part of the Government System. The open portion shown in the bottom of Figure 76 is used to readily open or shut based on the system's needs. As described by the manufacturer:¹⁹⁸

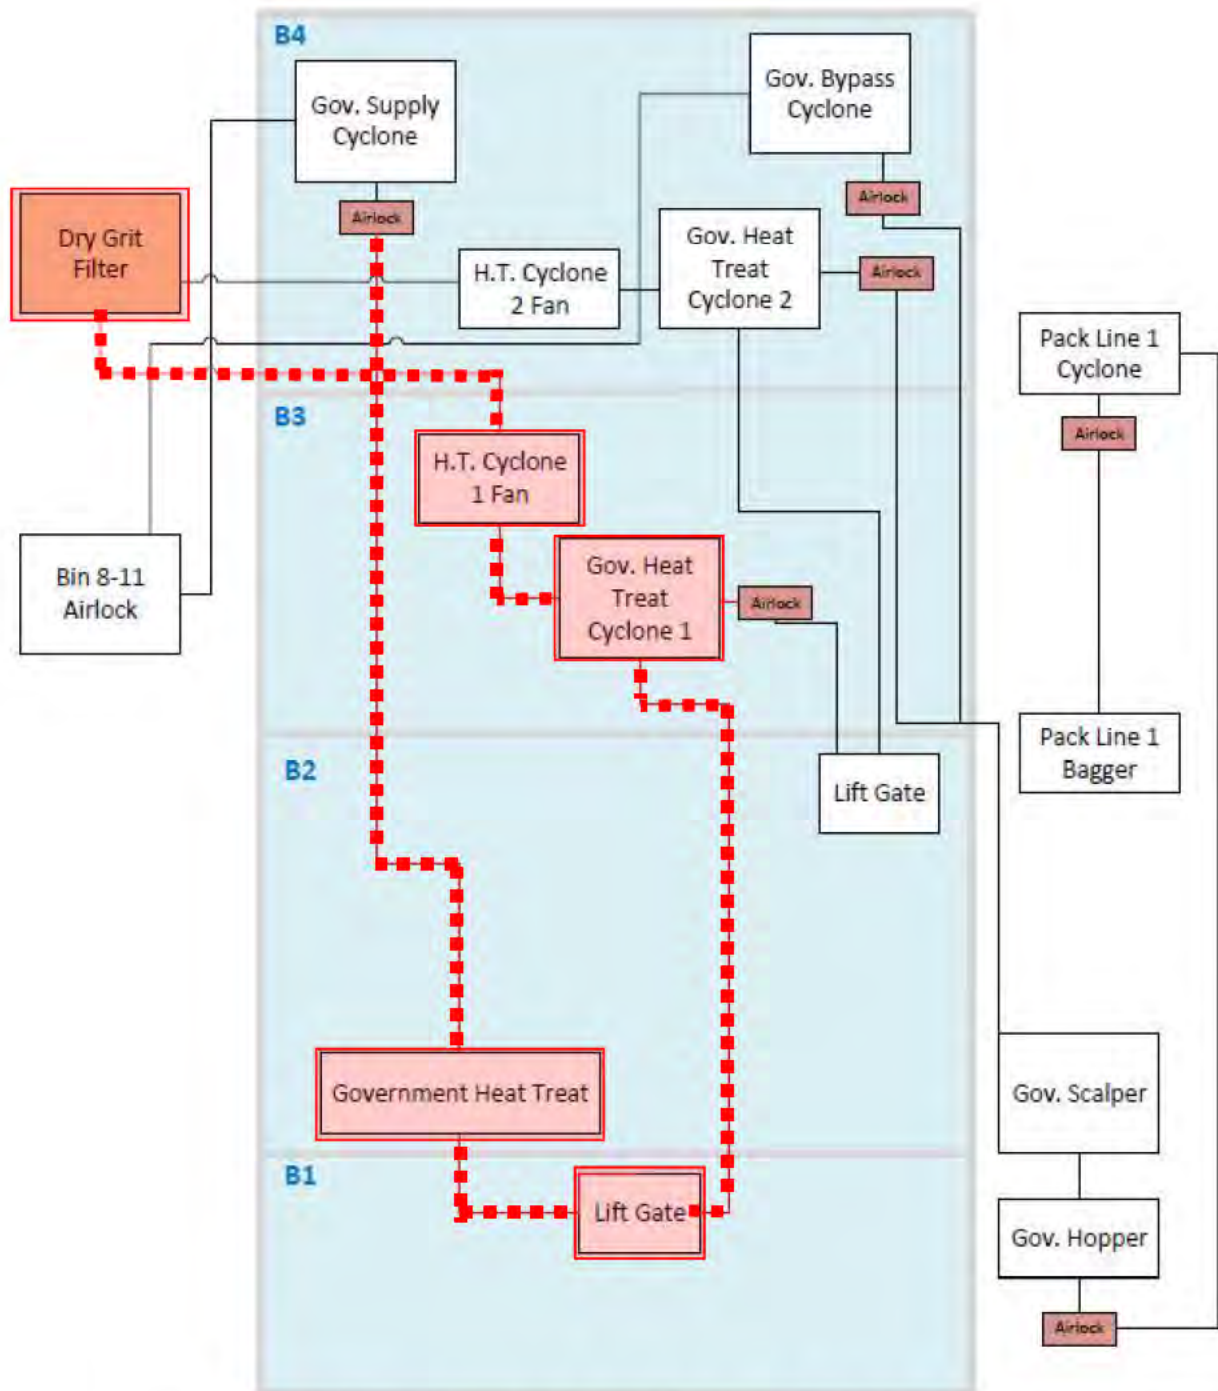
Figure 78. PFD of the Government System in the B-Mill with propagation pathway shown in red.

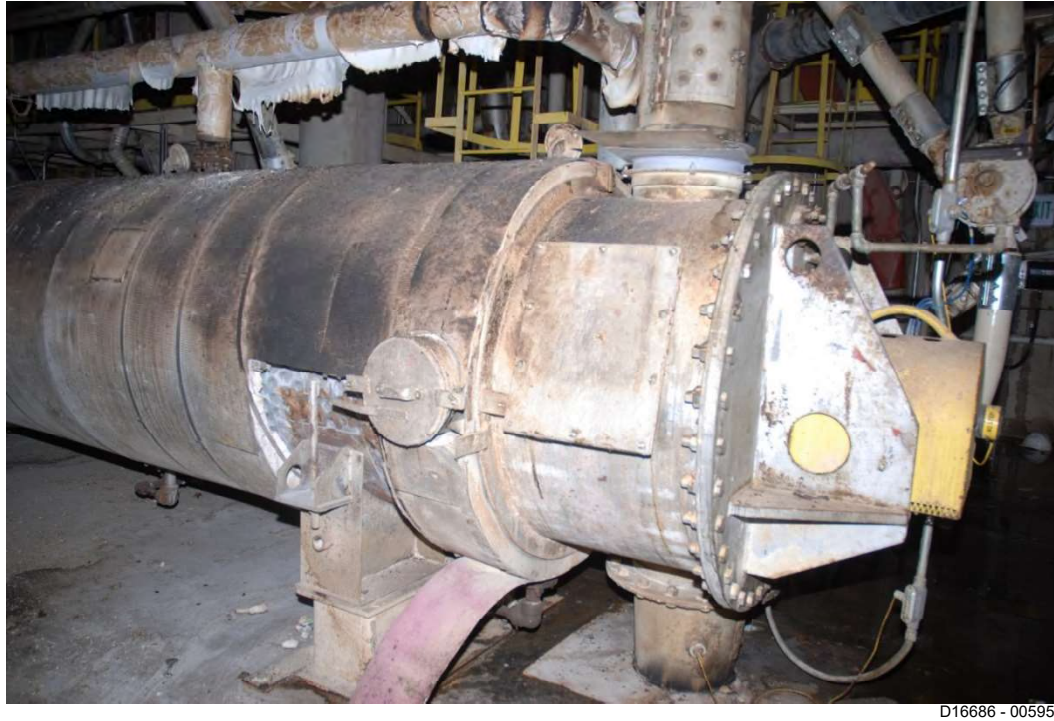
Figure 79. Post-incident view of Government Heat Treat Eclipse on 2nd floor of B-Mill.

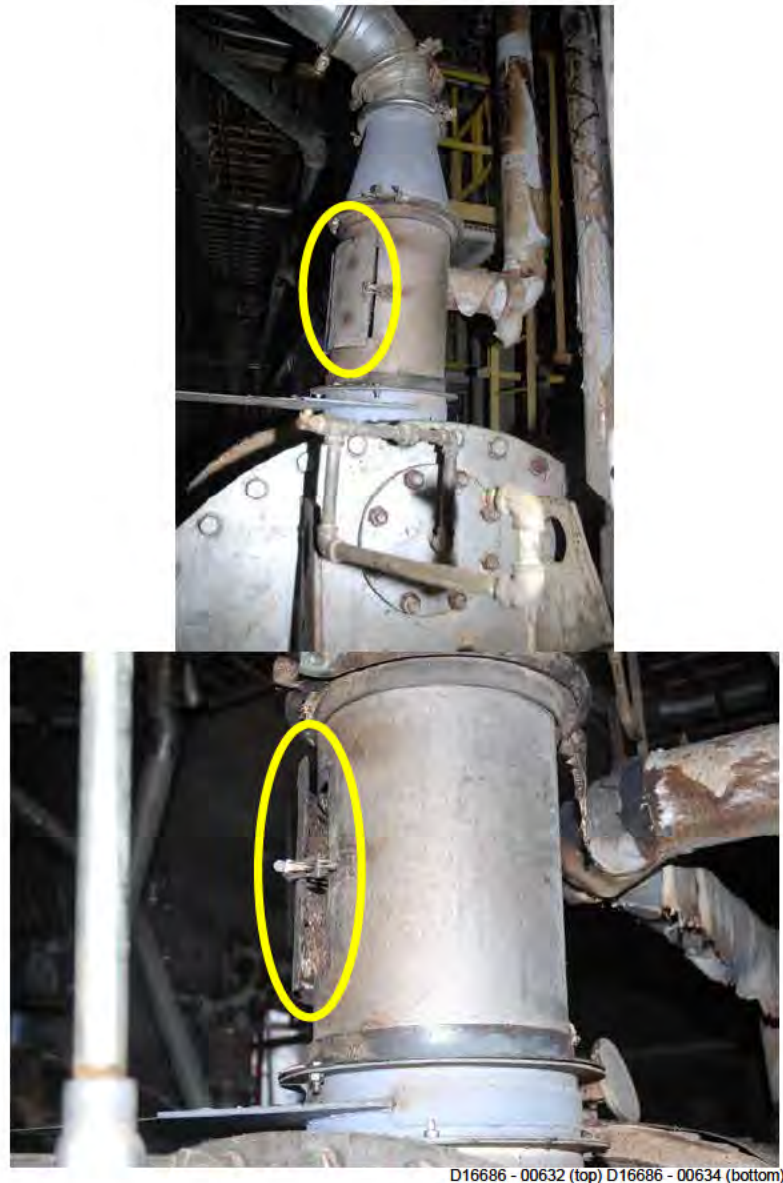
Government System is enclosed, there is a door on the top of the Heat Treat Eclipse. Close-up photographs of this access door are shown below in Figure 80. From these photographs, the access door on the Government Heat Treat Eclipse is shown to have opened during the incident, and charred fuel is seen on the inside of the door from the flame/explosion propagation, consistent with a propagation event initiating at the Government Line lift gate in B1.

Figure 80. Post-incident view of Government Heat Treat Eclipse on 2nd floor of B-Mill (zoomed in).

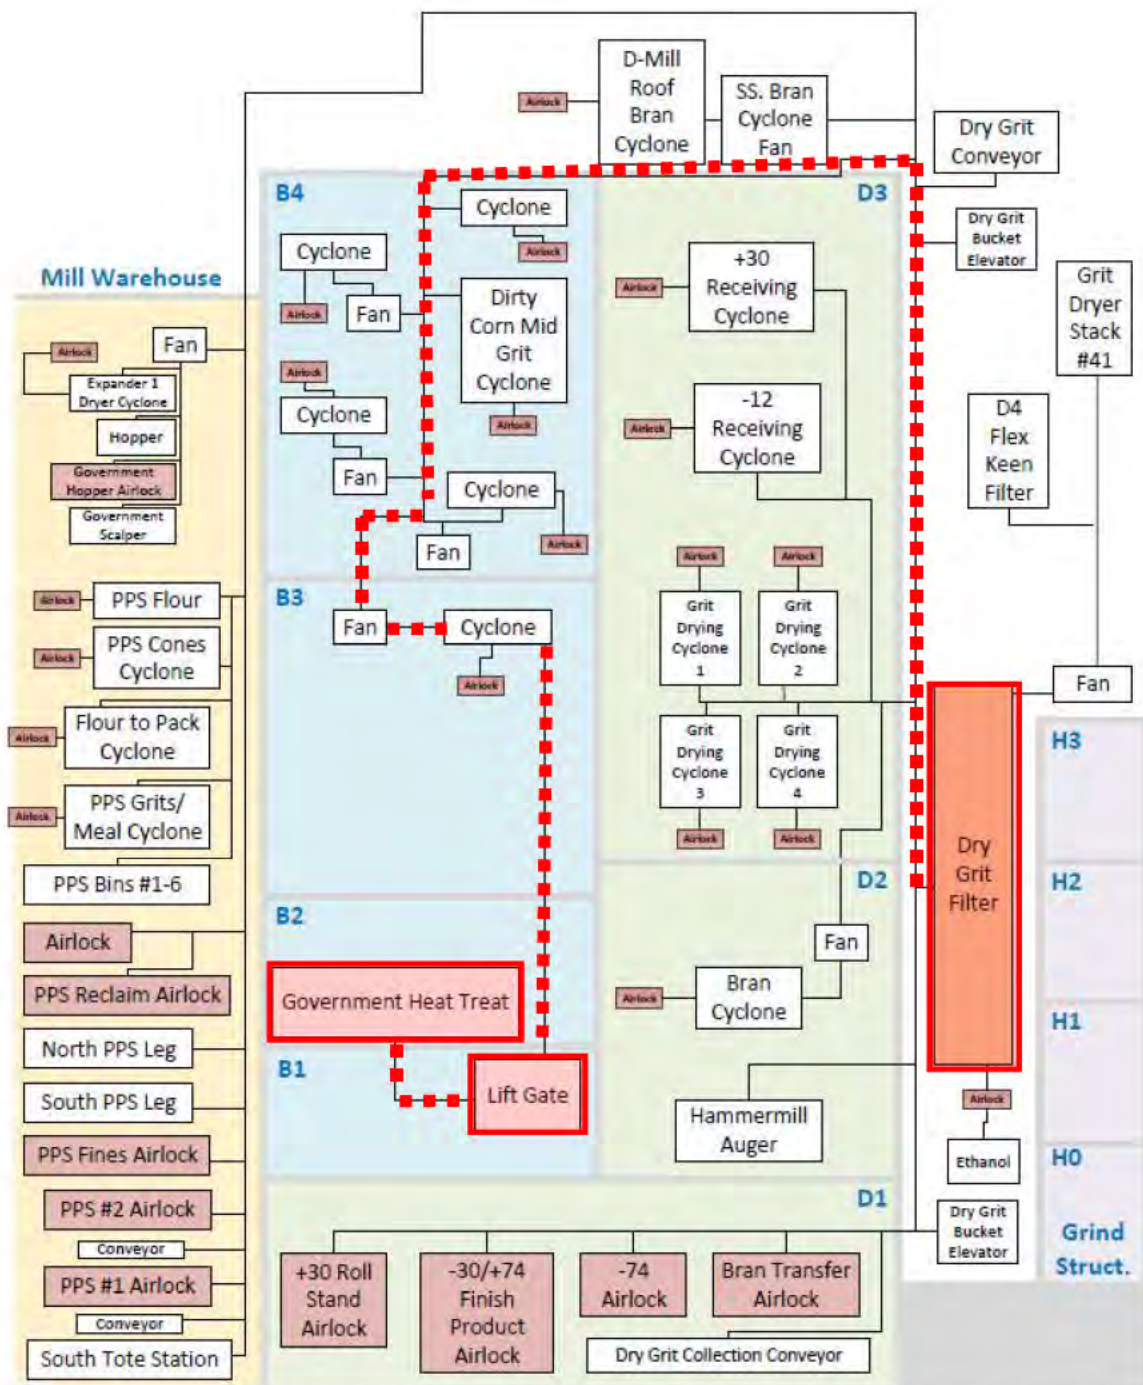
Figure 81. Flame Propagation from B1 to the Dry Grit Filter, which is connected to rest of Mill (Warehouse, B-Mill, D-Mill, and Grind Structure). The propagation pathway from the government system to the dry grit filter is shown in red.

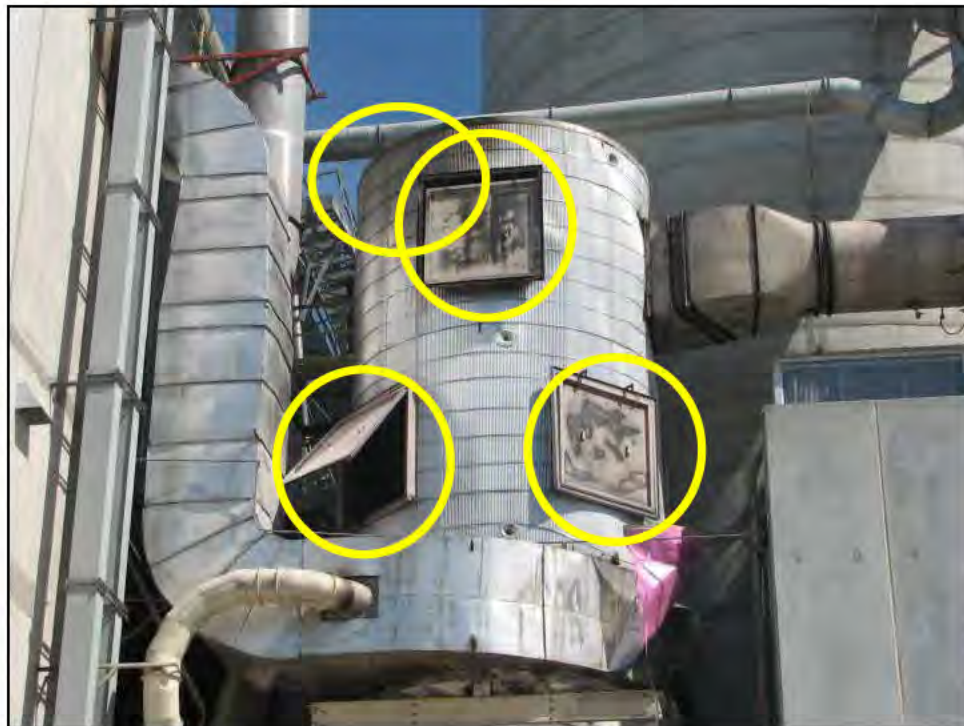
D16641 – 0084 (cropped)

The Dry Grit Filter was located on the outside of the D-Mill shown below in Figure 82. This piece of equipment was located outside of the mill buildings but connected through multiple ducts to different areas of the mill (Mill Warehouse, B-Mill, D-Mill, and Grind Structure) shown previously in Figure 81. Witnesses observed an explosion venting from the Dry Grit Filter within seconds of the explosion in B1.^{199,200} Figure 82 shows the open explosion panels on the Dry Grit Filter, consistent with this observation. The only viable means for propagation of an explosion to the Dry Grit Filter was *internally* through the ducts that feed it.

Figure 82. Post-incident view of Dry Grit filter mounted to side of D-Mill.

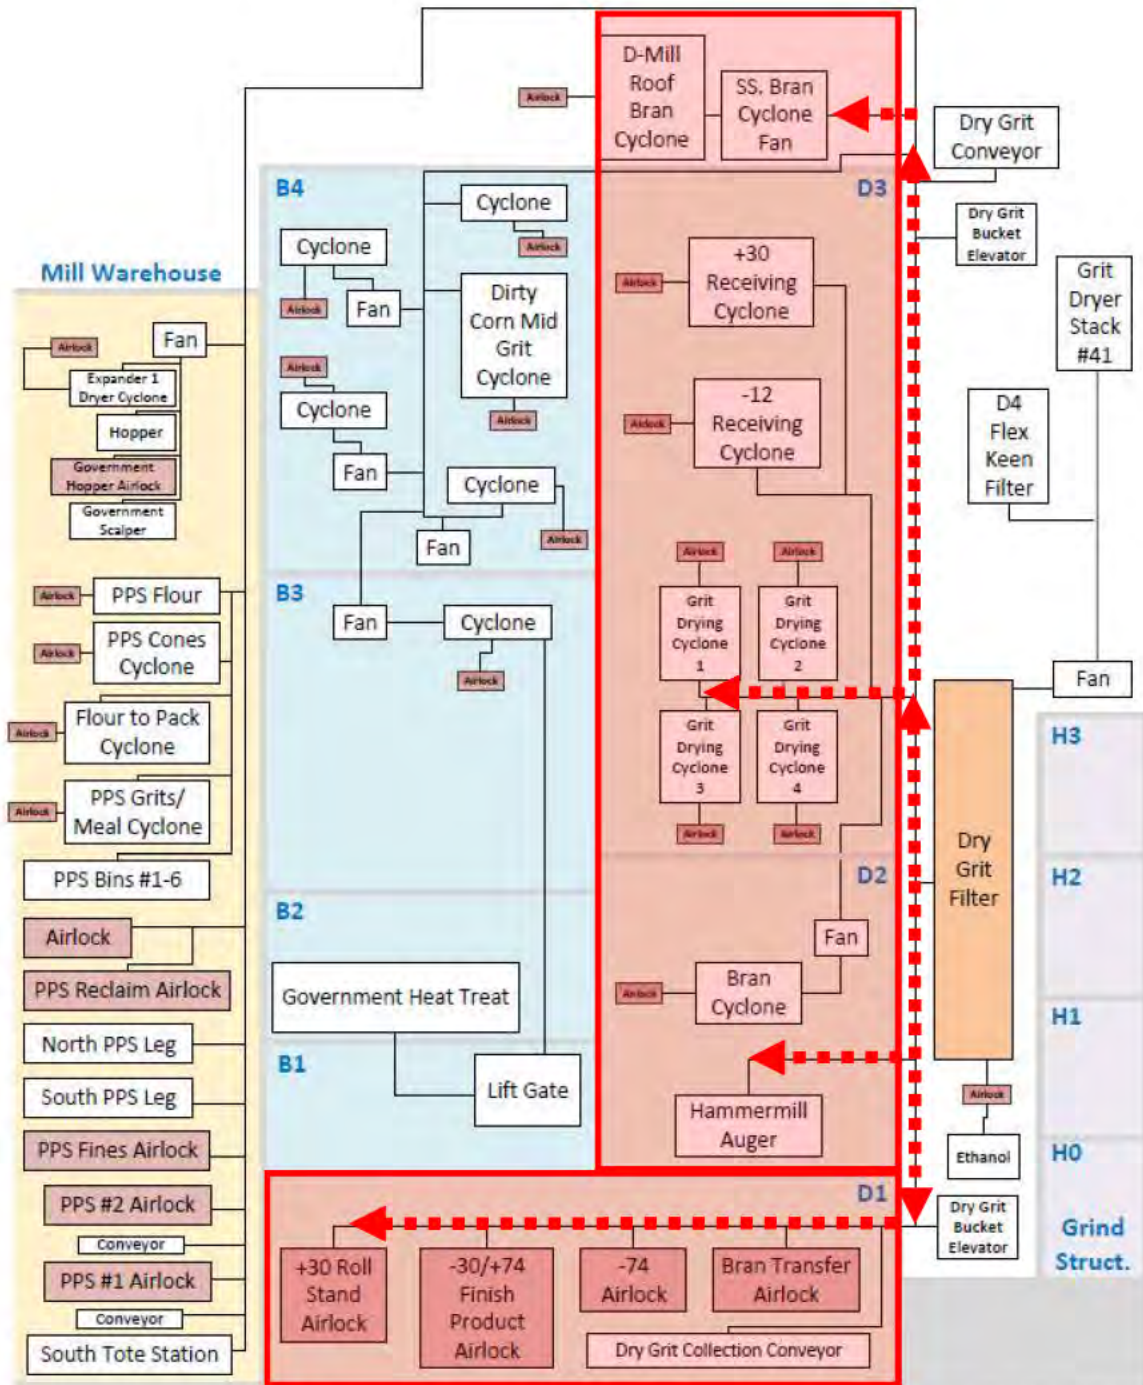
The ducting from the Dry Grit Filter going into the top of the D-Mill is connected to additional ducting inside the D-Mill as shown in Figure 83. Four Grit Drying Cyclones that also feed the Dry Grit Filter in the D-Mill are shown below in Figure 84. As observed in the photo, extensive

Figure 83. Dry Grit Filter to D-Mill with propagation shown in red.

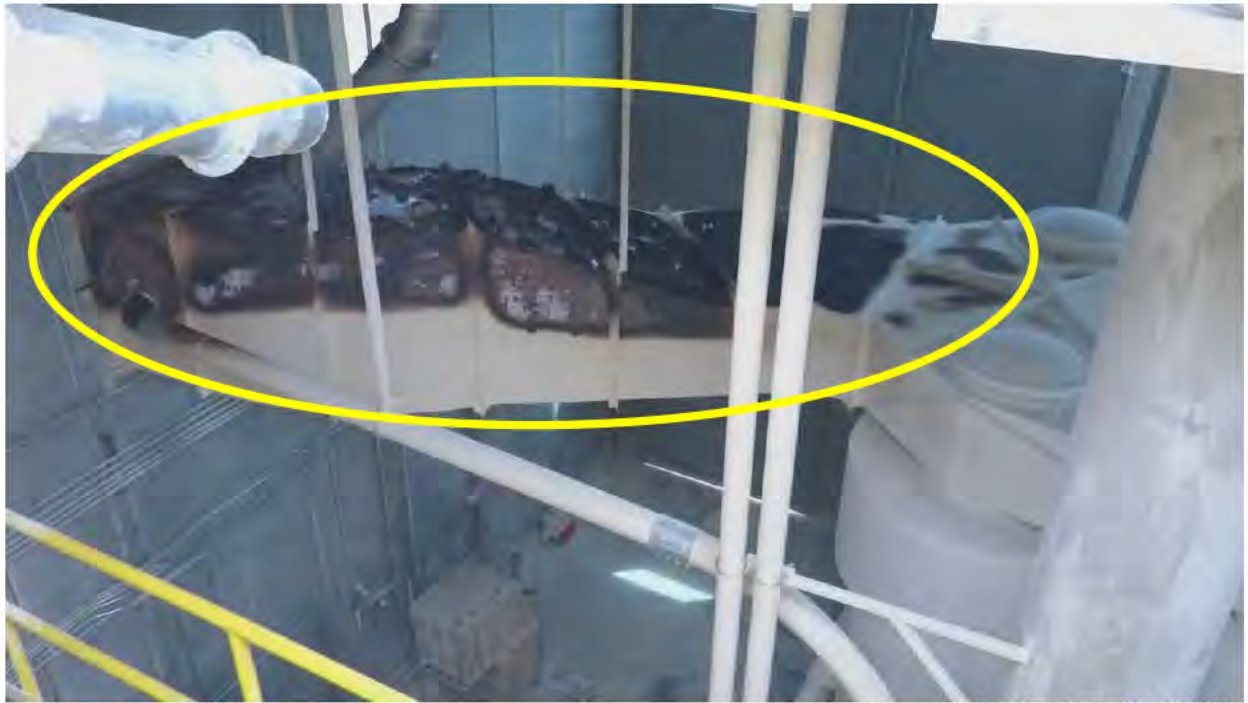
06-08-17 Drone Footage (DJI_0001 MOV)

fire damage occurred from the inside the duct between the Dry Grit Filter and the Grit Drying Cyclones in the D-Mill. Additional equipment was affected within the D-Mill but was unable to be photographed extensively due to safety concerns regarding the building's post-explosion integrity. The drone footage captured shows internal overpressure experienced in the D-Mill equipment (from the caps blown off lines and flattened ducts) resulting in extensive ejection of products as shown in Figure 85.

Figure 84. Post-incident aerial view of duct connecting the Dry Grit Filter and Grit Drying Cyclones in the D-Mill.
